“Full” Reserve Study

Callicotte Ranch HOA **Carbondale, CO**

Report #: 31243-0
For Period Beginning: January 1, 2017
Expires: December 31, 2017
Date Prepared: November 14, 2016

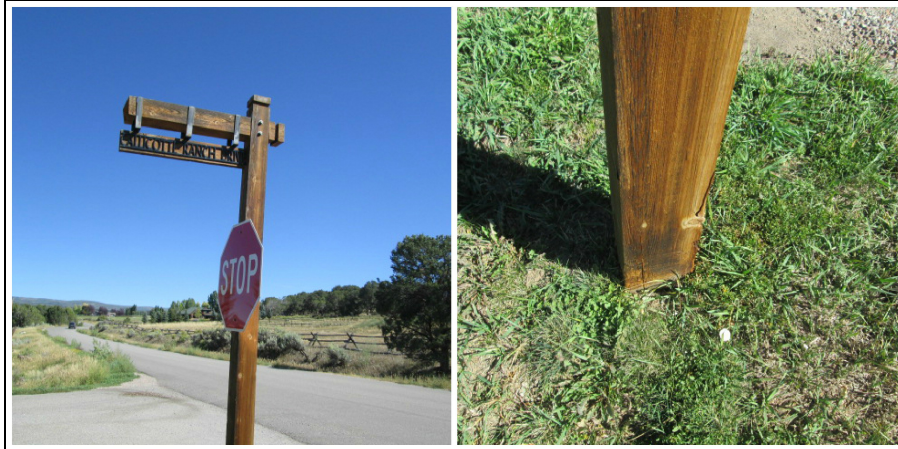
Evaluation: At the time of inspection, overall good conditions were noted. There were not problems observed or reported. The cedar posts were not installed in concrete, which may require replacement sooner than if concrete were used. Decorative street signs and posts are generally replaced at long intervals due to constant weathering and deterioration. As a routine Operating expense, signs should be inspected to make sure visibility is adequate, including at night. Repair any damaged or leaning posts as needed. In our experience, associations should replace signage at the rough interval shown below in order to maintain good aesthetic standards in keeping with the local area.
